Automatic cleaning - A redundant Oil in Water Analyzer design for reliable data in dirty environment

MIRMORAX

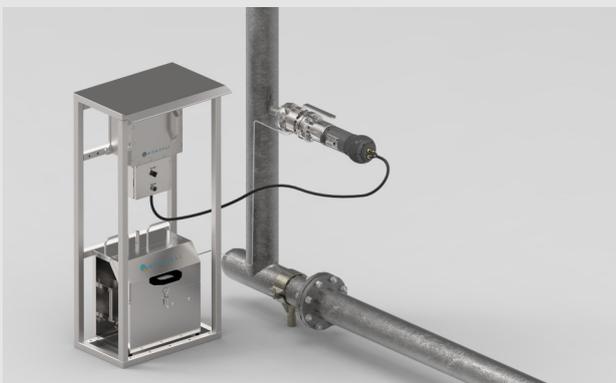
Mirmorax Oil in Water Analyzer providing reliable measurements without manual cleaning. Initial plan was to remove the probe for inspection after 3 months although measurements results revealed that the cleaning system kept the transducer clean with no requirements for inspection nor manual cleaning.
